THE PROJECT

The Save our Seagrass (SOS) project is led by Wild Planet Trust. This report describes the seagrass assessments that took place at Fishcombe Cove, Brixham and Beacon Cove, Torquay.

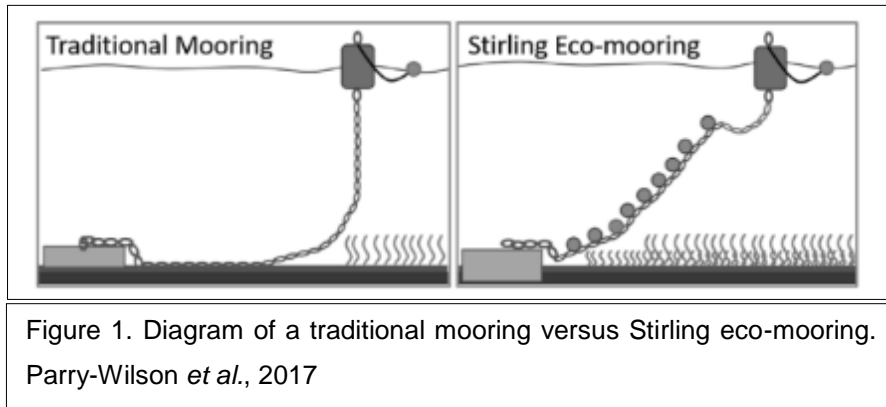
The AMS that were installed on the 14th October 2021 are Stirling Eco-Moorings, developed by the Ocean Conservation Trust (Figure 1.). These work by attaching a series of floats to the mooring chain to lift them off the seabed, therefore reducing drag. The presence of three moorings spaced evenly within the relatively small cove will hopefully reduce the number of anchoring occurrences.
